# Manhole Inspection Summary

Manhole # S39UU\_017MH

Insp Date: **12/19/06 11:51 AM**

**Location** Address: **752 30TH ST**

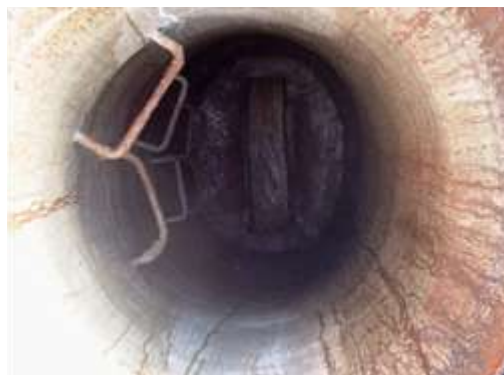
Top View

Infiltration: ☐ None ☒ **Joint** ☐ Cracks ☐ Mortar ☐ Roots ☒ **Wall**

Infiltration: ☐ None ☐ Joint ☐ Cracks ☐ Mortar ☐ Roots ☒ **Wall**

**Steps** Count: **6** Missing: **0** ☒ **Corroded**

Adjustment and Barrel infiltration.  
Corroded steps.

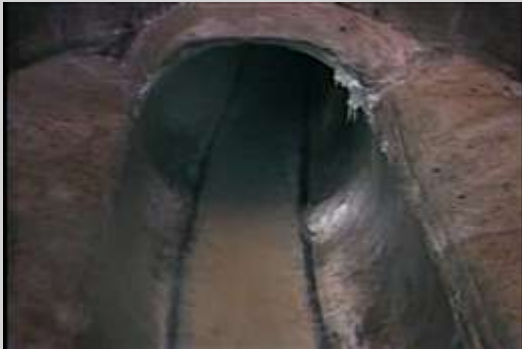
### 18 in. Circular Gravity Sewer Pipe Out @ 12 O'Clock

Pipe Material: **Unknown** ☒ Pipe Lined

Invert Depth: **11.81** (ft.) Flow Characteristics: **Fast**

Infiltration: **None** Pipe Seal Cond: **Unknown**

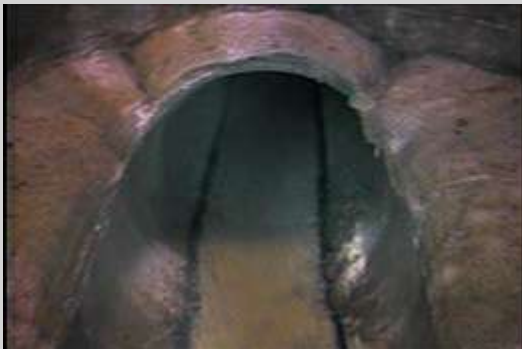
### 18 in. Circular Gravity Sewer Pipe In @ 5 O'Clock

Pipe Material: **Unknown** ☒ Pipe Lined

Invert Depth: **11.70** (ft.) Flow Characteristics: **Fast**

Infiltration: **None** Pipe Seal Cond: **Unknown**
